Navajo Abandoned Uranium Mine

Site Screen Report

Mine Name: Big Four No. 2
Mine ID: 519

Navajo AUM North Central Region

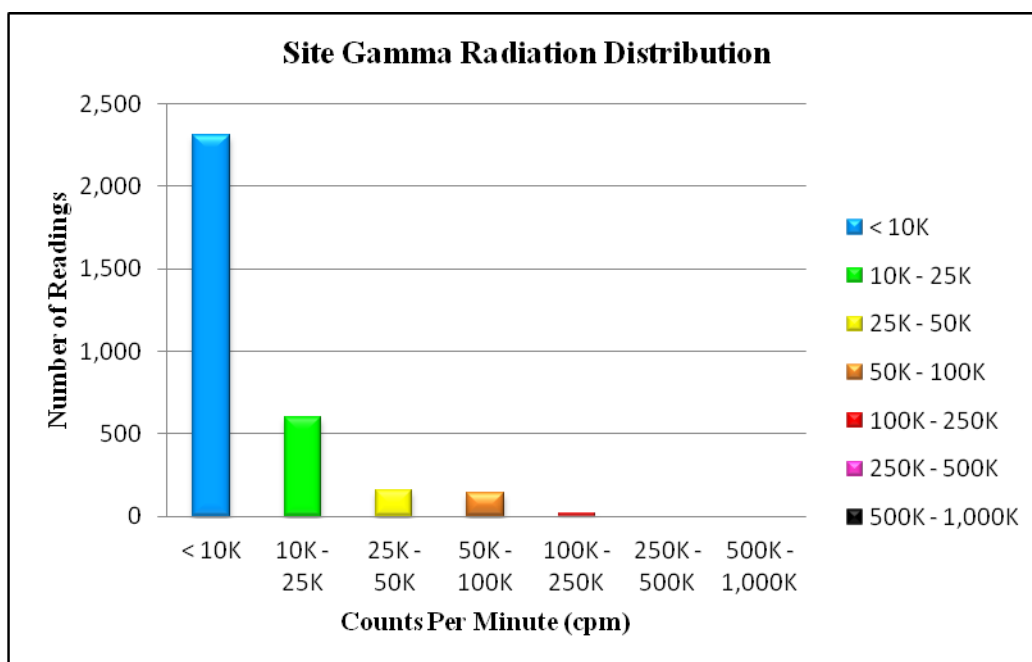
Distribution Chart and Statistics:

Site Gamma Radiation Statistics	
Number of Readings	3,228
Minimum (cpm)	5,386
Maximum (cpm)	150,653
Mean (cpm)	13,901
Median (cpm)	8,581
Standard Deviation	16,487

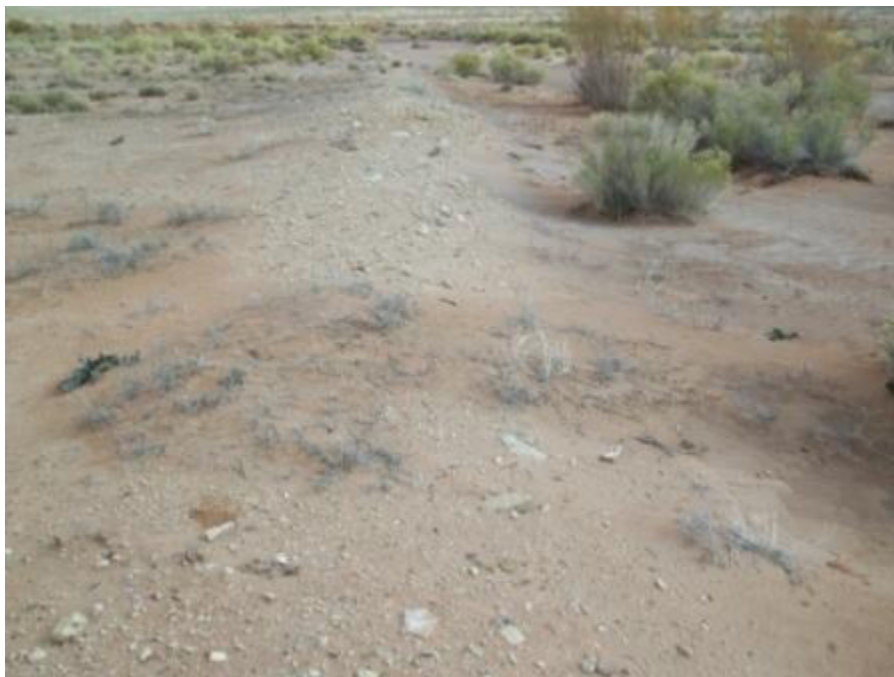
Photo 1

Standpipe in the northern part of the site; berm along the wash that has been cut by a meander

Mine Site #519 – Bermed area

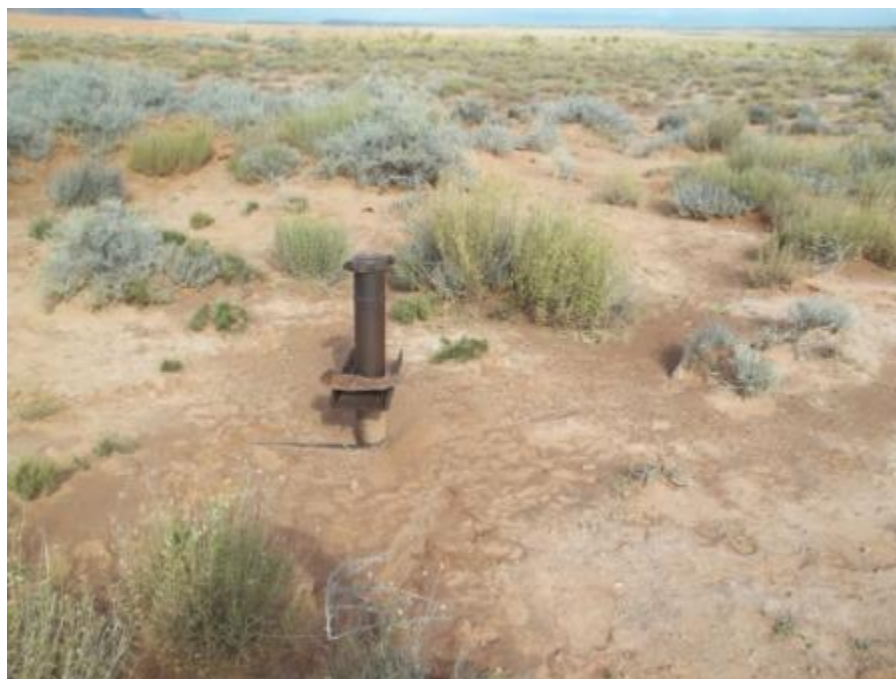
Photo 5

0 to 0.25 miles: Onsite - Well (519)

Mine Site #519 - Well

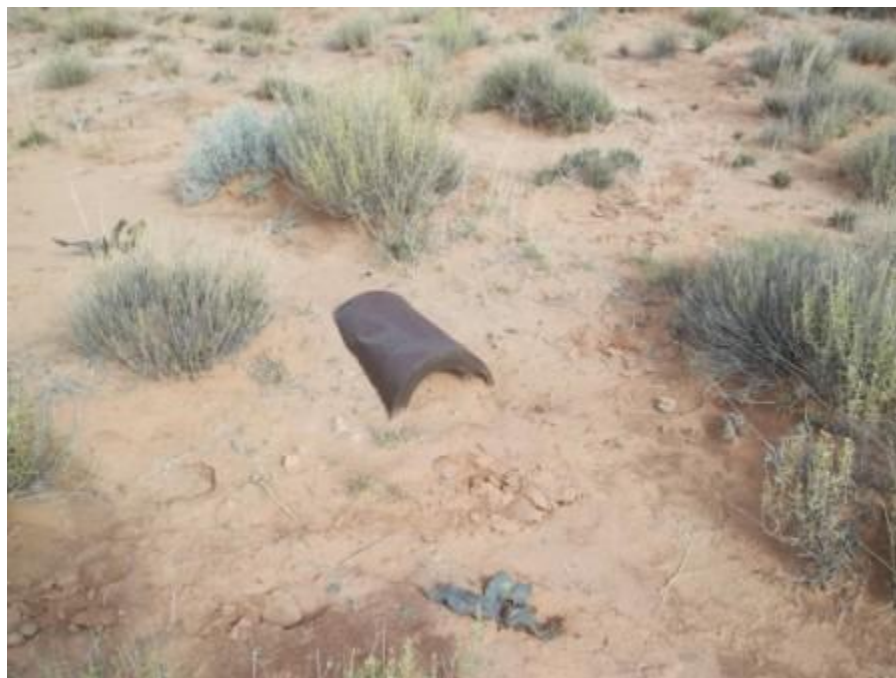
Photo 6

Mine Site #519 – Mining debris

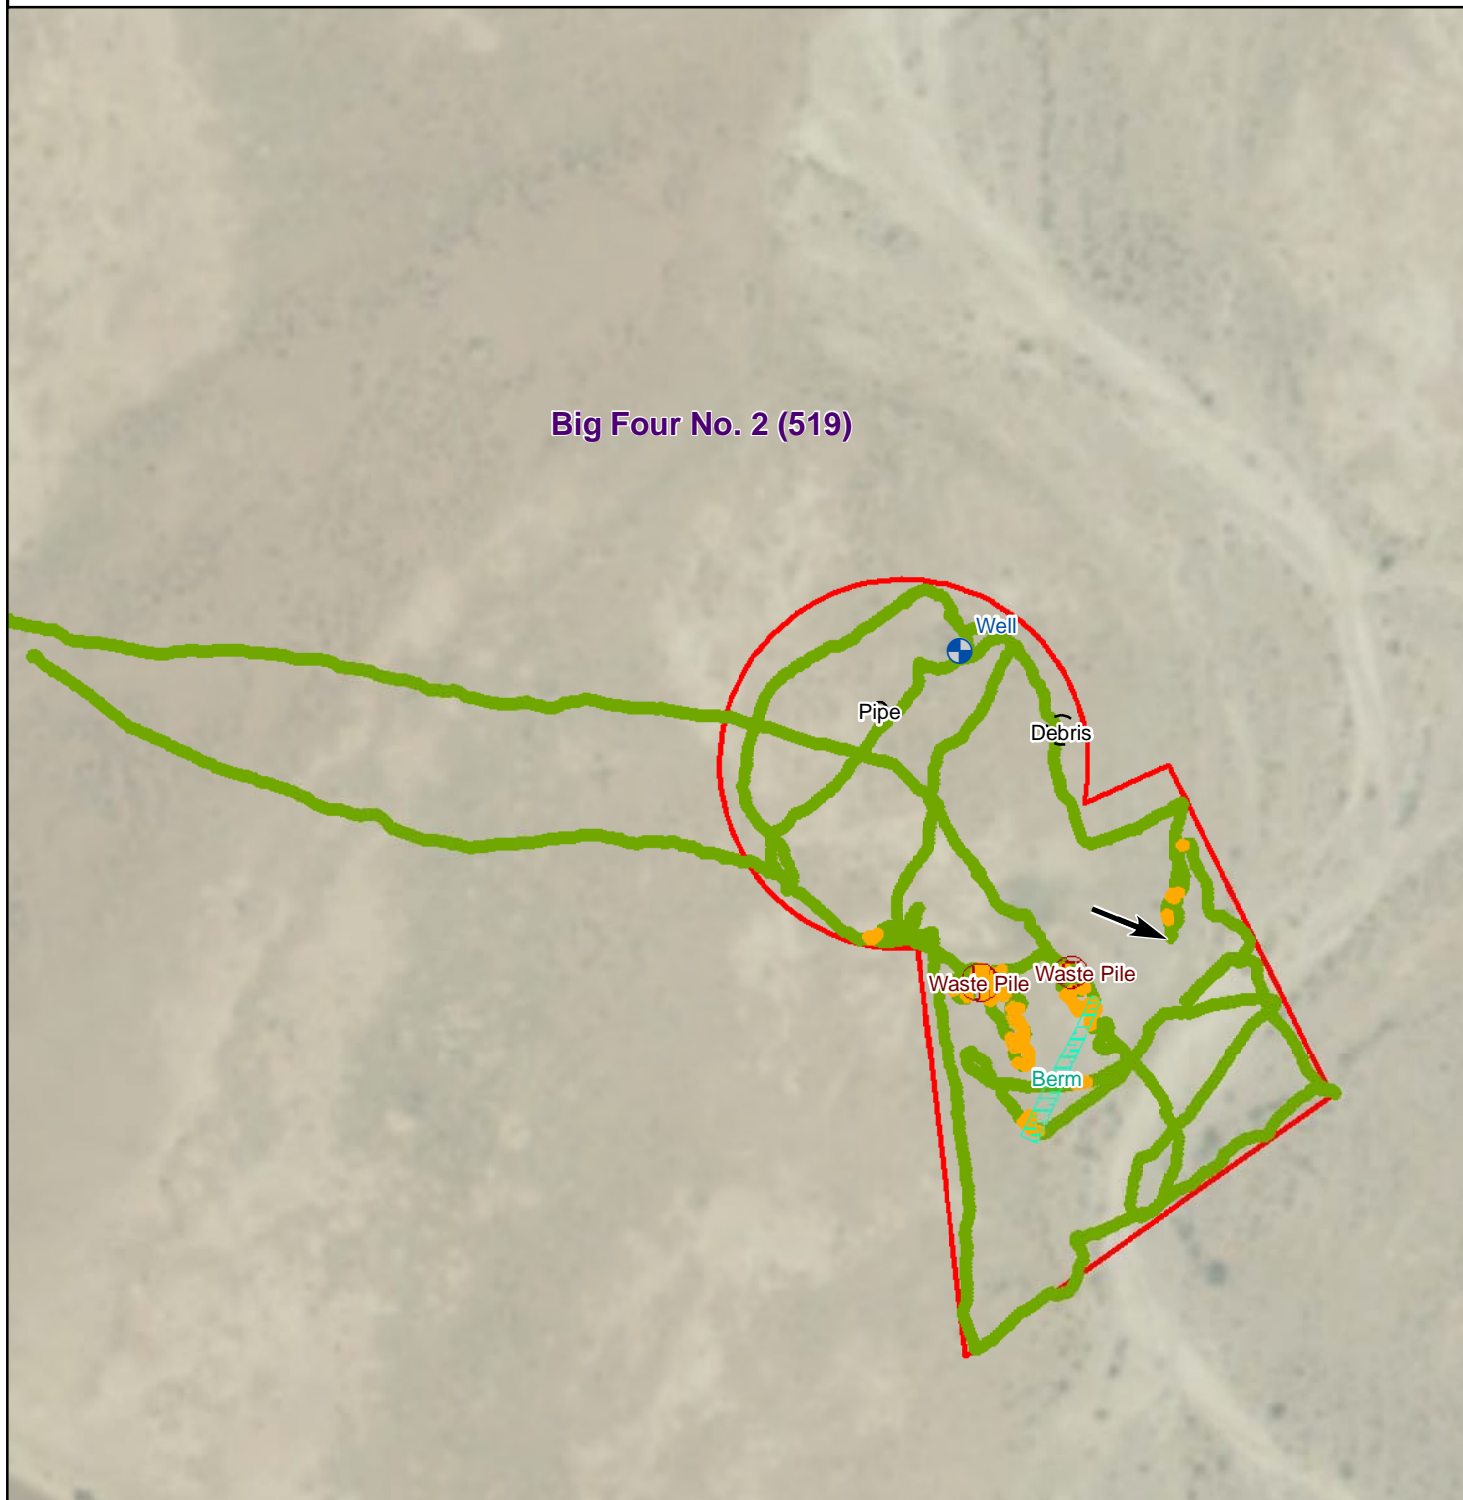
**Figure 1 - Gamma Radiation Measurements, Above Two Times Background
Big Four No. 2 (519)
Oljato Chapter, Navajo Nation**

A total of 3,228 gamma radiation measurements were collected from the mine site, ranging from 5,386 cpm to 150,653 cpm. Maximum levels of approximately 150,000 cpm were found in the vicinity of the waste rock. The measurements are represented in Figures 1 and 2.

Measured as counts per minute (cpm)

Average background 6,902 cpm

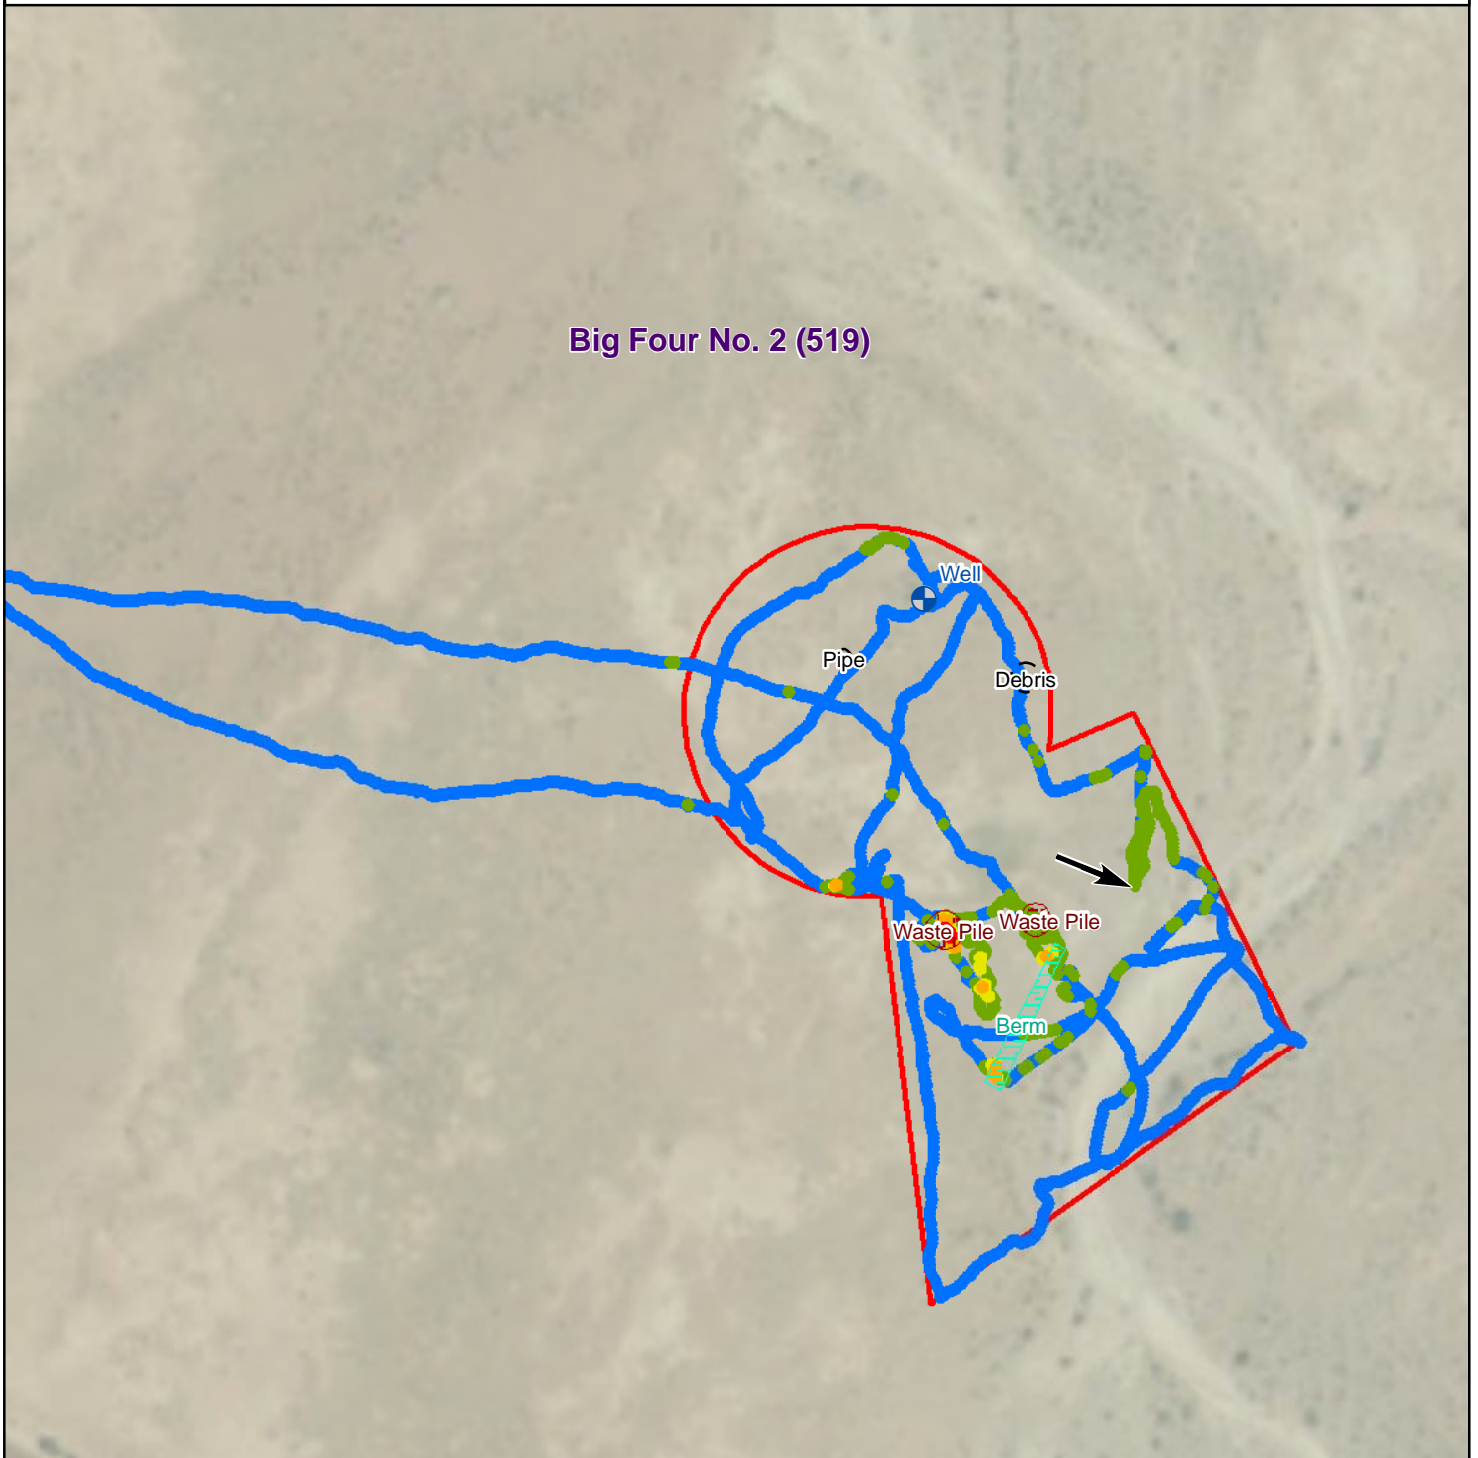
Figure 2 - Gamma Radiation Measurements
Big Four No. 2 (519)
Oljato Chapter, Navajo Nation

Average background 6,902 cpm

Measured as counts per minute (cpm)
